#### **Case Report**

# Usage of Point-of-care Ultrasonography for Rapid Diagnosis of Cardiac Perforation by Pacemaker Lead

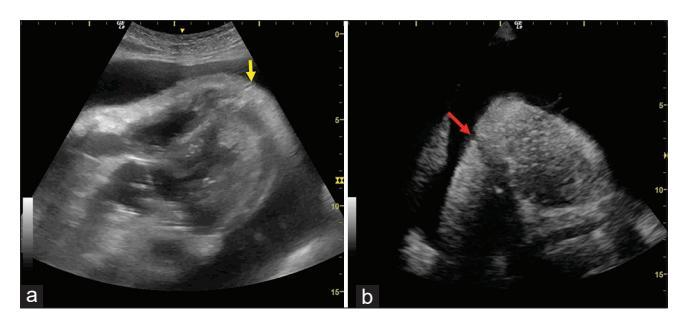
**Figure 1:** (a) Pericardial effusion and pacemaker lead (yellow arrow) protruding outside right ventricle free wall. (b) Pericardial effusion and discontinuation of right ventricle free wall (red arrow)

gastrointestinal bleeding episodes have been found. Physical examination revealed an engorged jugular vein with a distant heart sound. The nature of the shock was further studied using POCUS (GE LOGIQ-e, GE Healthcare, Milwaukee, WI). Huge heterogeneous pericardial effusion with early diastolic right ventricle (RV) collapse and free pacemaker lead protruding outside the RV free wall [Figure 1a] were present in the subxiphoid view. Apical four-chamber view also revealed discontinuation of the RV free wall [Figure 1b], suggested RV free wall rupture. Emergent pericardiocentesis was performed by draining over 200 ml of bloody fluid. Contrast-enhanced CT confirmed a pacemaker lead protruding outside the right ventricular wall with pericardial effusion [Figure 2]. The patient was shifted to the operating room, where he underwent cardiac repair. The pacemaker lead was found to be penetrating out of the RV free wall with a 1 cm lacerated, slowly bleeding wound. He had a smooth postoperative course with resolution of his symptoms, was discharged home in a stable condition, and was doing well on follow-up 1 month later.

Lead perforation is suspected when <3 mm separates the tip of the lead from the epicardial fat detected on chest X-ray (epicardial fat-pad sign).<sup>[10]</sup> Although chest radiography is the initial choice of diagnostic tool, it may not be able to detect minimal lead migration. In this case, perforation was difficult to diagnose on chest radiography as the tip of the lead was outside the RV free wall and lying just above the diaphragm. While CT remains the gold diagnostic tool for precisely demonstrating the pacemaker lead position<sup>[10]</sup>, POCUS is a timely, efficient, effective, and patient-centered alternative in the ED setting. By recognition of new-onset pericardial effusion in patients with pacemaker or ICD implantation by POCUS, emergency physicians should search evidence of displaced lead along the free wall of RV and apex because lead perforation is one of the uncommon causes of pericardial effusion that needs surgical intervention.

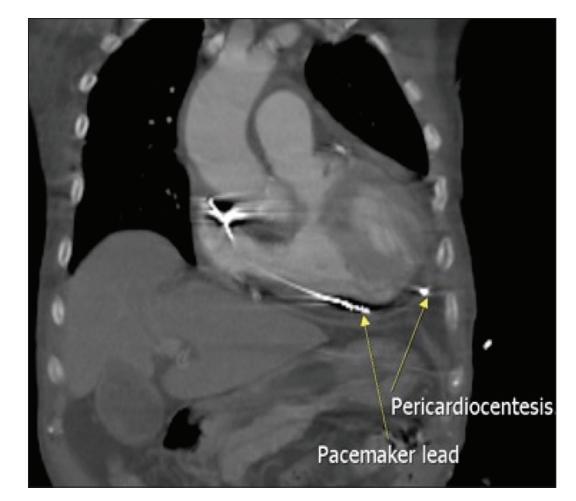
Figure 2: Computed tomography of chest confirmed free pacemaker lead protruding to right ventricle wall with pericardial effusion
